Vehicle Inspection Report

Order ID: #159

Mercedes-Benz CLA 2021

VIN **W1K1183881N123456** | EU **4415 NDK** | Fuel: **Diesel** | Transmission: **Automatic**

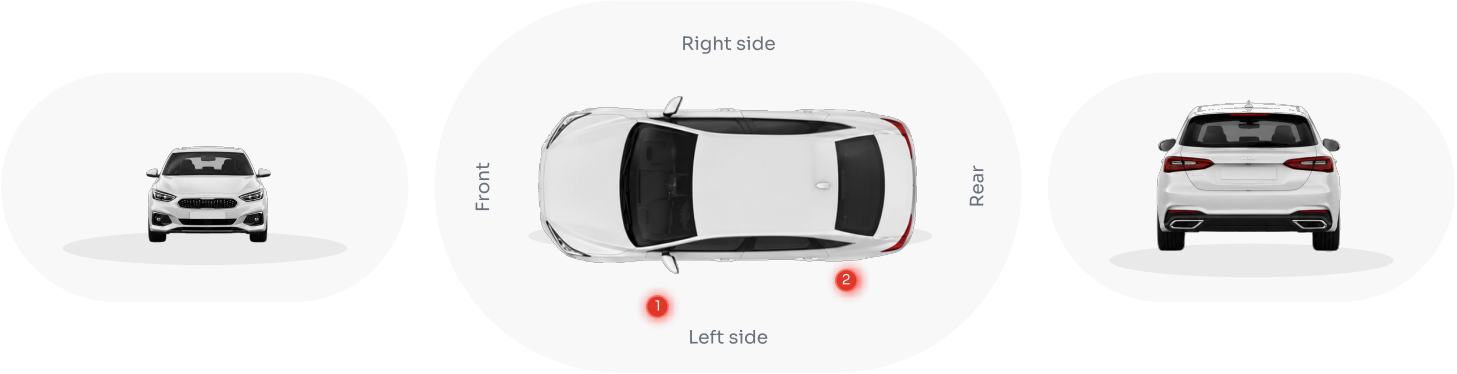
#	Part	Damage	Severity	Inspector Note
1	Front Left Door	Dent	Med	Shallow dent on the front-left door with paint scuffing along the crease line. No deeper structural damage detected. Paintless dent repair feasible; light touch-up over the scuff recommended.
2	Left Rear Fender	Scratch	Med	Scratch along the rear-left fender, roughly 12 cm long, paint layer compromised but no metal deformation. Polishing or local touch-up recommended.
